HISTORIC STRUCTURE REPORT

GRUBER WAGON WORKS

PHILADELPHIA DISTRICT U.S. ARMY CORPS OF ENGINEERS

JOHN MILNER ASSOCIATES WEST CHESTER, PENNSYLVANIA

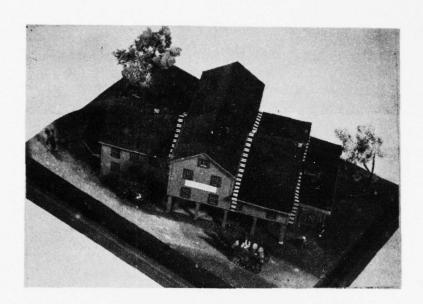
A) Model of Wagon Works Showing General Separation Planes

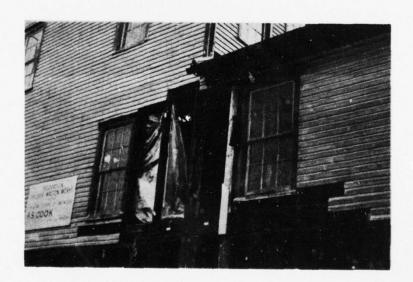
B) Removal of Siding Along Separation Plane

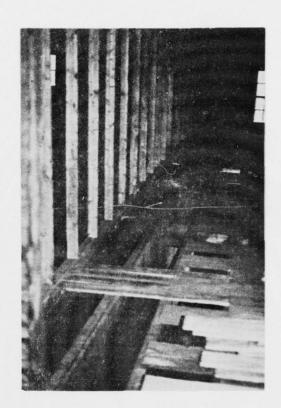
A) Removal of Flooring Along Separation Plane

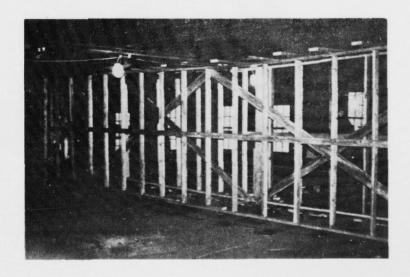
B) Structural Reinforcing

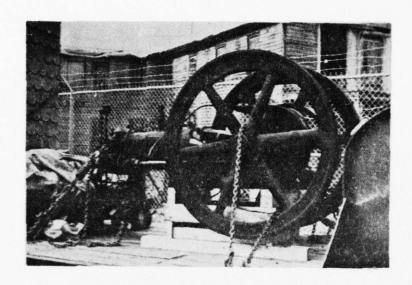
A) Otto Engine During
Relocation

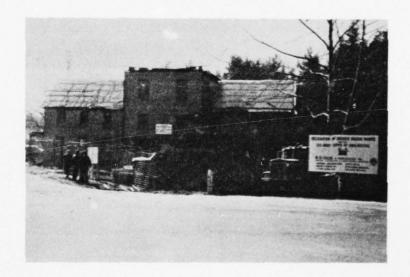
B) Elevator Penthouse Gable Roof Removed

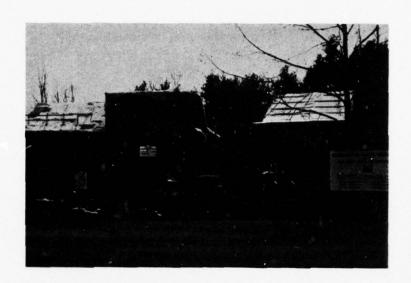
A) Separation into Major Sections

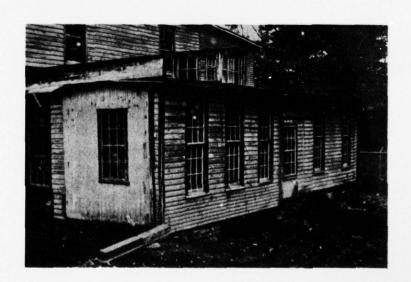
B) Needling Stringers Through Pierced Foundation

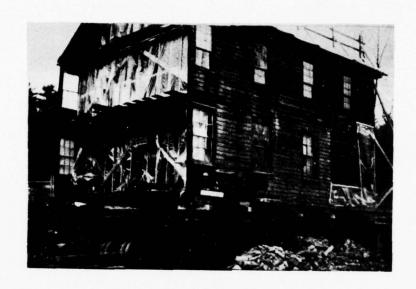
A) Section Rigged On Stringers, Beams and Dolleys

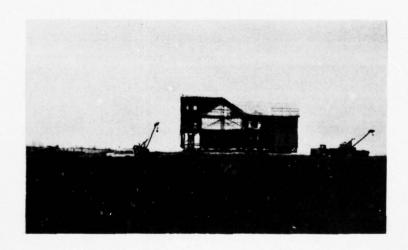
B) Movement of Largest Section Over Highway

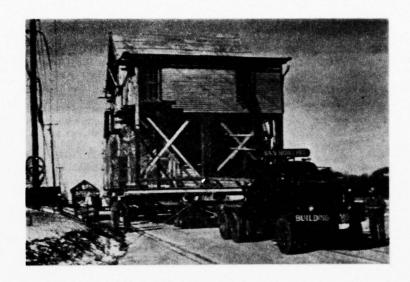
A) Movement of Flanking Sections Over Highway

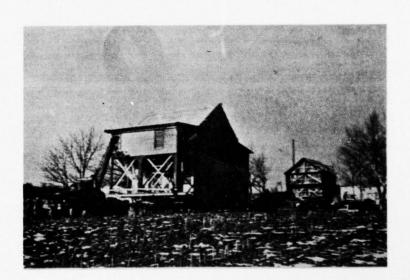
B) Movement Through Field

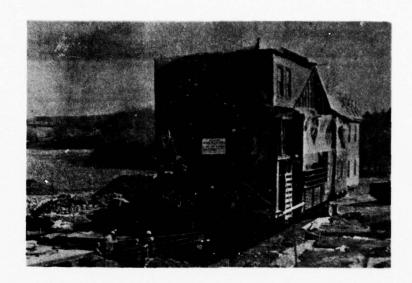
A) Movement of Largest
Section into New Location

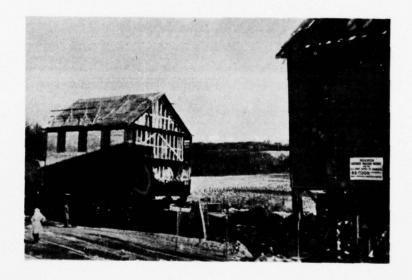
B) Movement of East Flanking Section into New Location

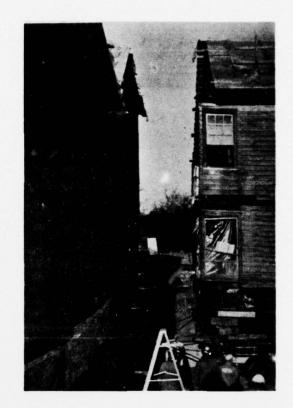
A) Movement of East Flanking Section into New Location

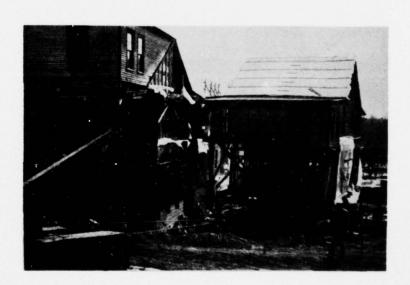
B) Movement of West Flanking Section into New Location

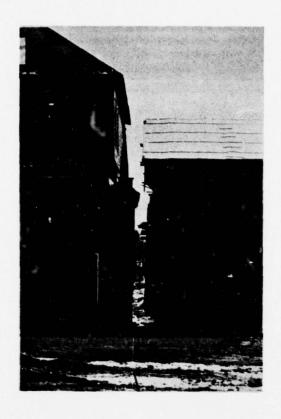
A) Movement of West Flanking Section into New Location

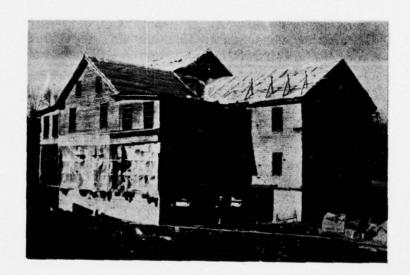
B) Reassembly Construction

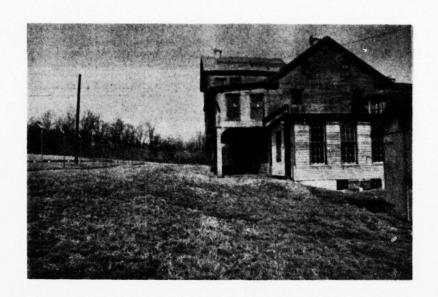
A) Northwest Corner of Structure Showing Existing Grading

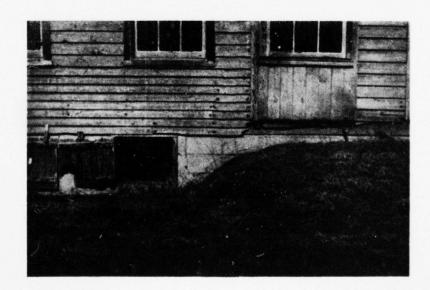
B) Grading Detail; Openings F002, F105, F106

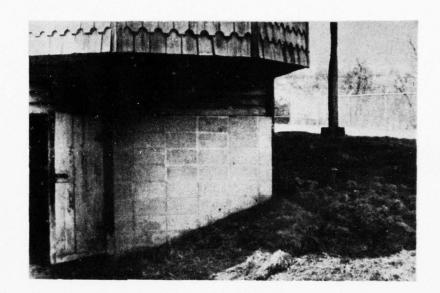
A) Grading Detail, Office Addition "D-3", Southeast Corner

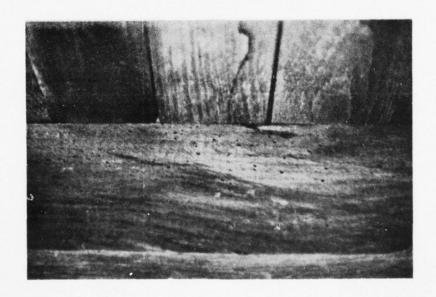
B) Indication of Powder Post Beetle Infestation

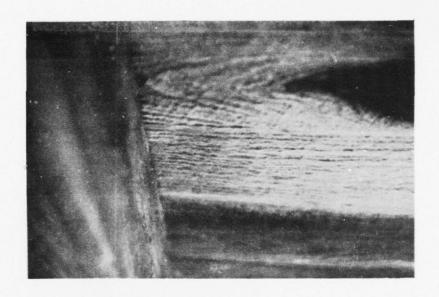
A) Fungus Indicating Early Rotting

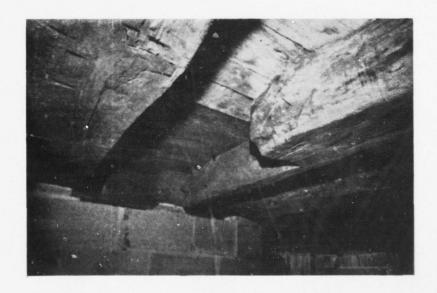
B) Cellar Room 901, First Floor Joist, Southeast Corner

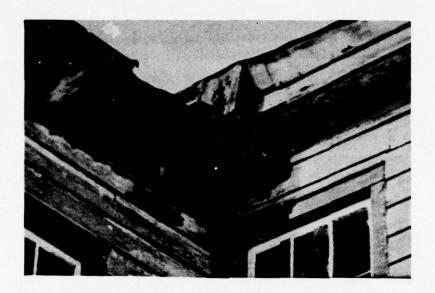
A) Deteriorated Roof Juncture, Section N-1 and B (West Elevation of B)

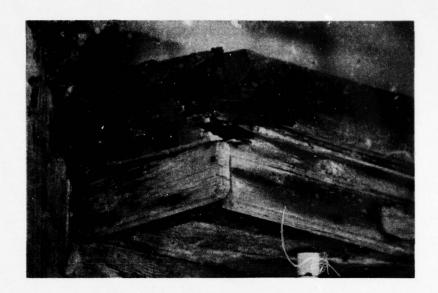
Plates A6-16 elevations of addition B, which are approximately eighty percent deteriorated.

B) Deteriorated Cornice, Section B, West Elevation

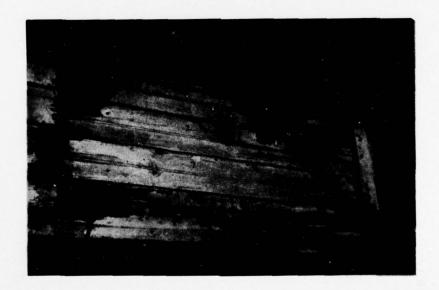
B) Broken Copening
